## Case 363 : Narrative

Case Vehicle (A): 2002 GMC	Vehicle (B): 1989 Chevrolet
Type: Envoy SLT, 4-door, 4x4 SUV	Type: Caprice Classic, 4-door sedan
Driver: 37-year-old male	Driver: 16-year-old male
CDC: 12-FDEW-3, 09-LPEW-2	CDC: 12-FZEW-4, 99-0000-0

This is a fatal crash, the right-front passenger of case vehicle (A) died as a result of a lacerated aorta.

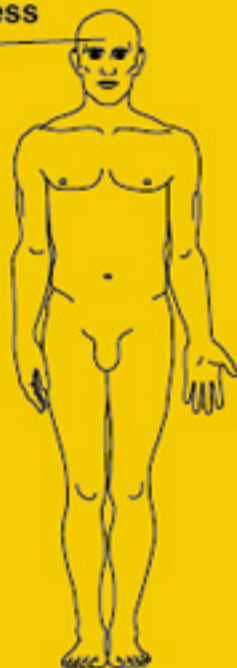
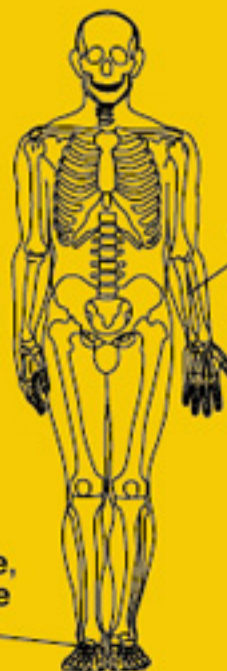
CASE NO.: 363-03

Loss of consciousness  
(2)

Comminted fracture,  
medial apsect of the  
right talus  
(2)

Comminuted transverse  
fracture, mid-shaft of  
the left ulna  
(3)

Fracture, left  
thumb  
(1)

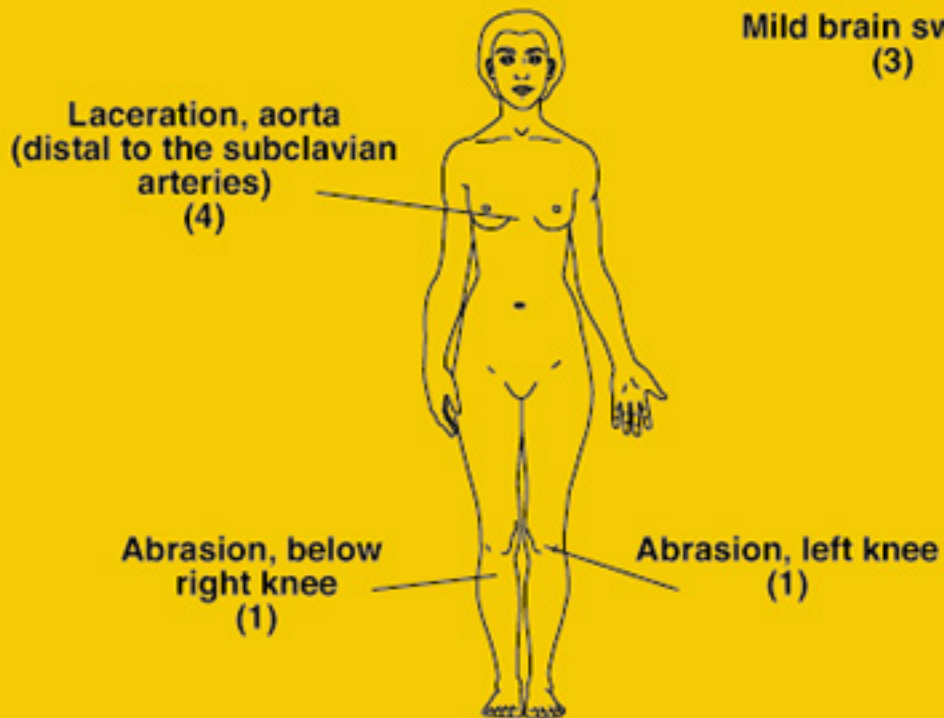
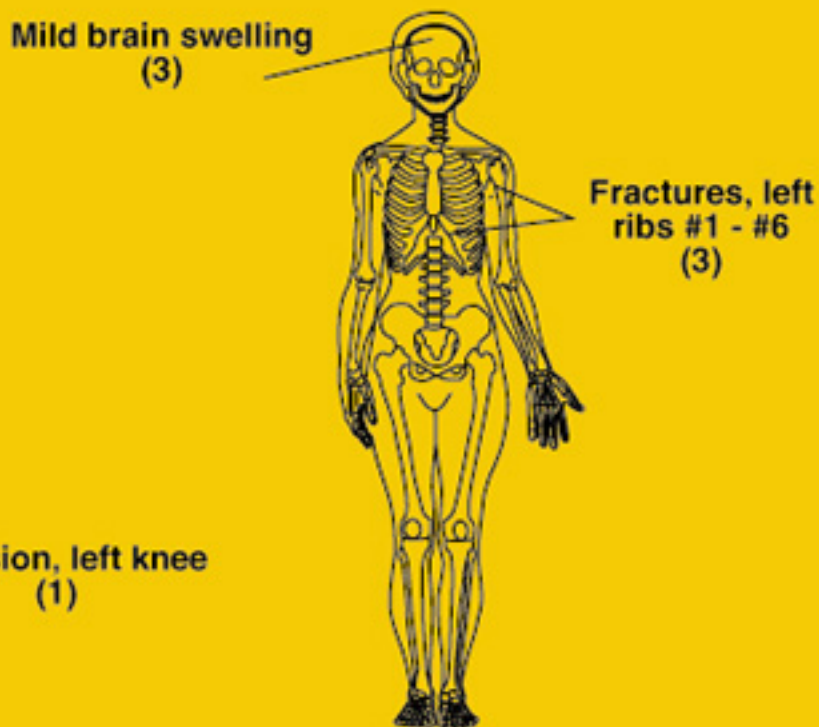
CASE NO.: 363-03

Autopsy report indicates death as a result of  
a lacerated aorta

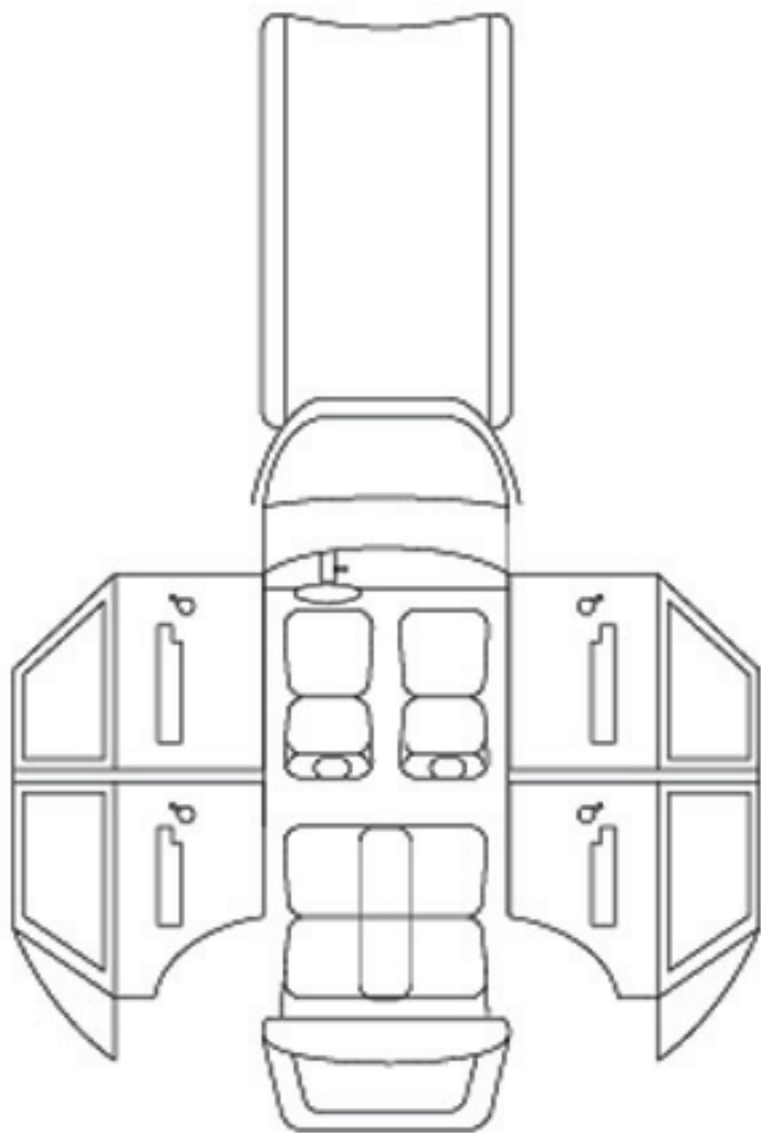
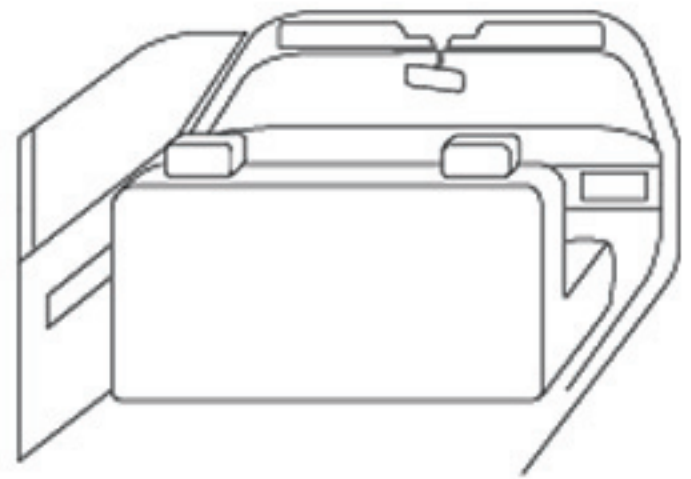
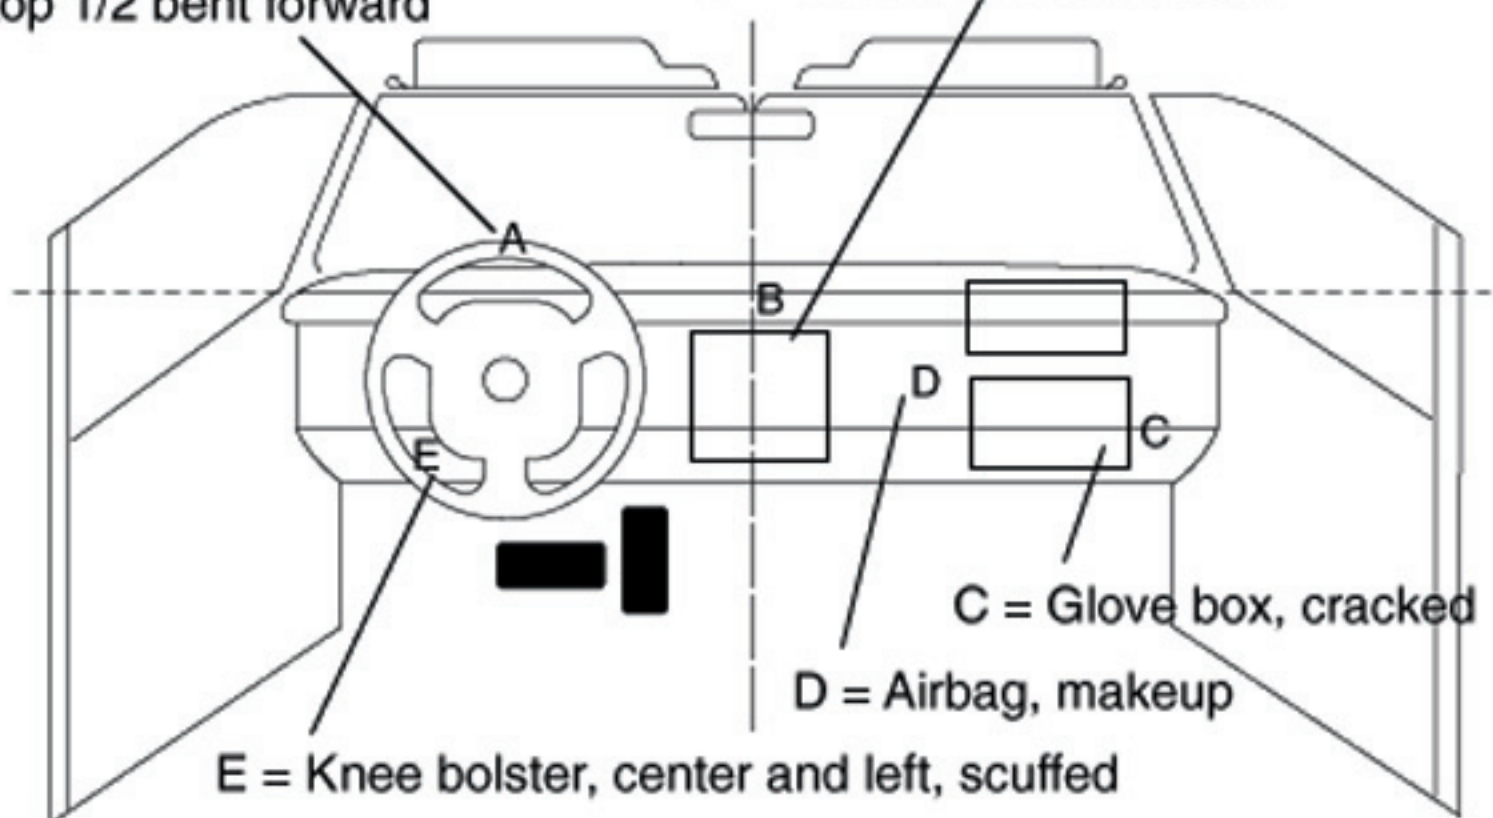
## OCCUPANT CONTACT WORKSHEET

A = Steering wheel rim,  
top 1/2 bent forward

B = Vertical console, scuff

C = Glove box, cracked

D = Airbag, makeup
